Manhole Inspection Summary

Manhole # S21AA2019MH

Insp Date: **11/20/06 1:48 PM**

Location Address: **5520 MATTFELDT AVE**

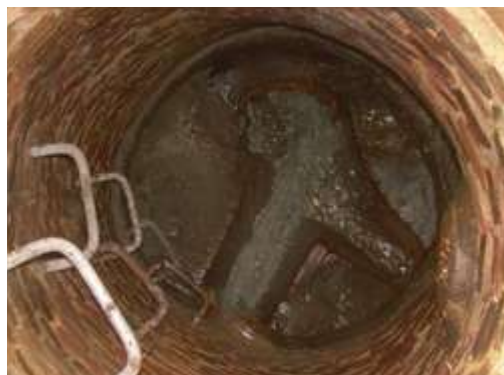
Top View

Corroded steps. Bench debris.

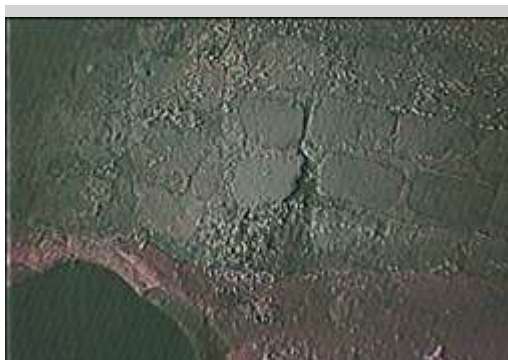
Defect

Barrel deterioration and infiltration.

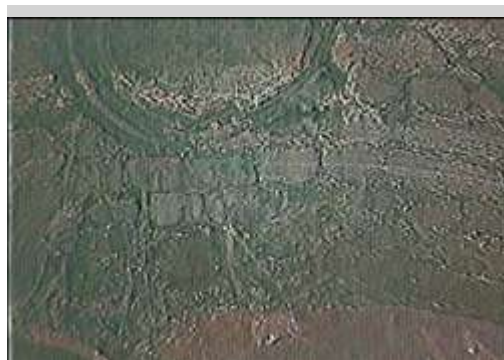
Defect

Barrel deterioration, root intrusion and infiltration (weeper).

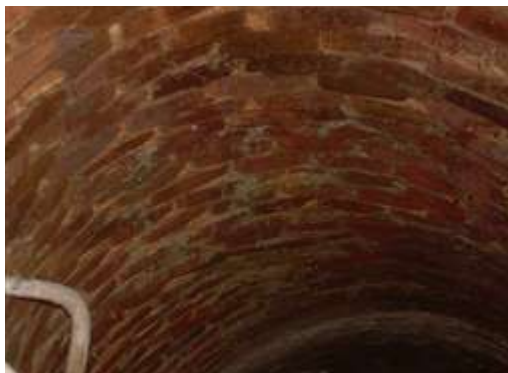
Defect

Adjustment, Corbel and Barrel infiltration.

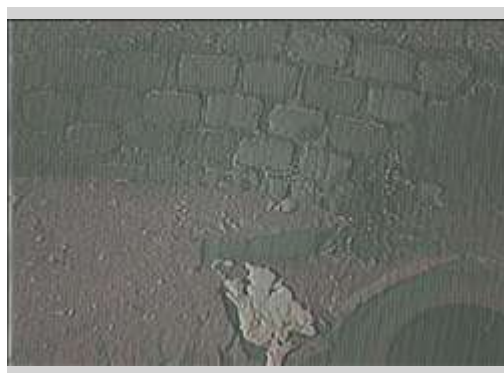
Defect

Barrel deterioration and infiltration (weeper). Bench debris.

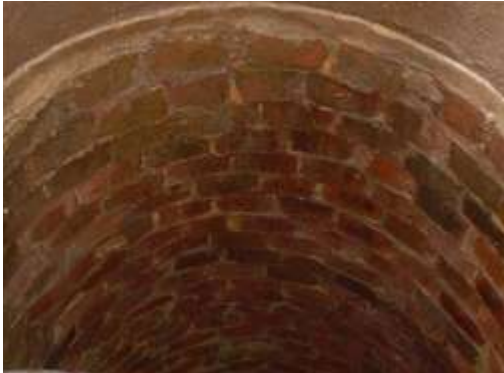
Defect

Frame leaks. Adjustment and Corbel infiltration.

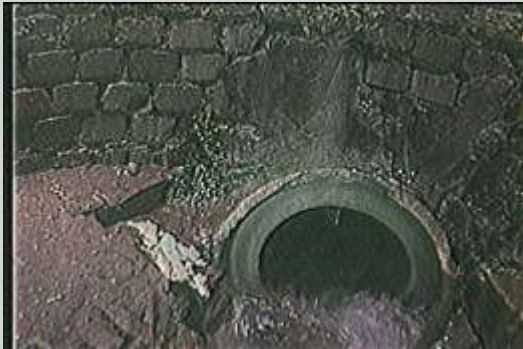
12 in. Circular Gravity Sewer Pipe Out @ 12 O'Clock

Infiltration: **None** Pipe Seal Cond: **Cracked**

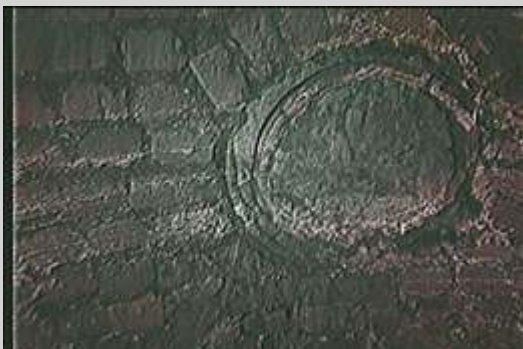
10 in. Circular Gravity Sewer Pipe In @ 2 O'Clock

Infiltration: **Evidence** Pipe Seal Cond: **Unknown**

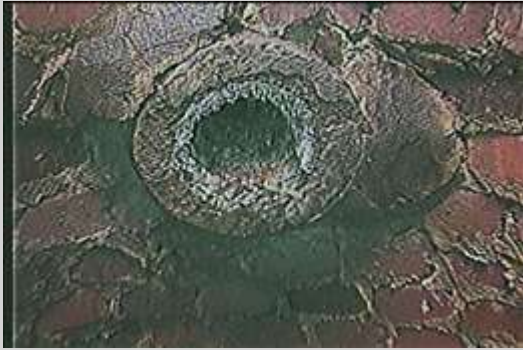
Pipe In @ 3 O'Clock

Infiltration: **Evidence** Pipe Seal Cond: **Unknown**

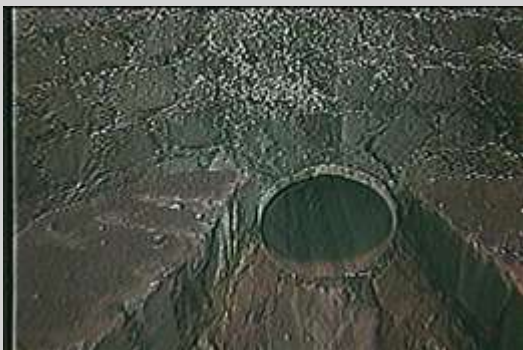
Pipe In @ 4 O'Clock

Channel deterioration and cracks.

Infiltration: **None** Pipe Seal Cond: **Cracked**

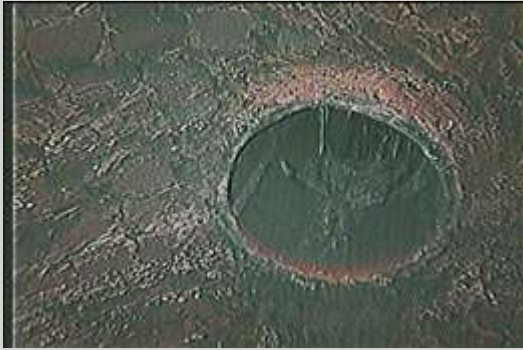
Pipe In @ 7 O'Clock

Pipe Seal Cond: **Broken**
